THE KALAMITY CLASS

A Failed Experiment in Steam-Powered Submarines

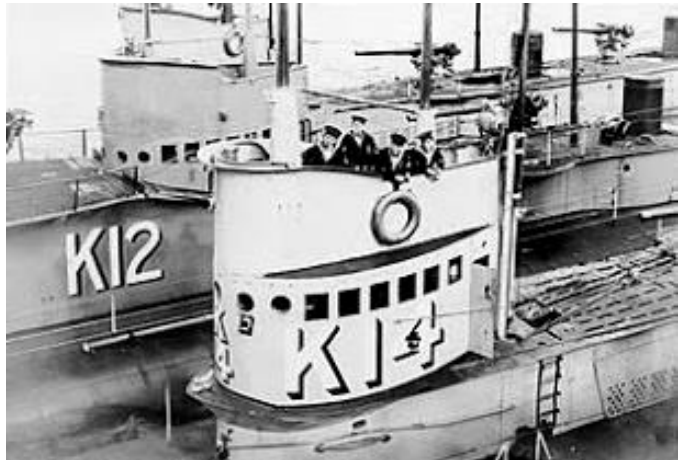
Adding to their unusual profile, the K-class submarines were fitted with a deckhouse that was constructed over and around the traditional conning tower. This feature provided better protection in rough seas for crew members during surface operations than was afforded the crews of other Royal Navy submarines of that era.

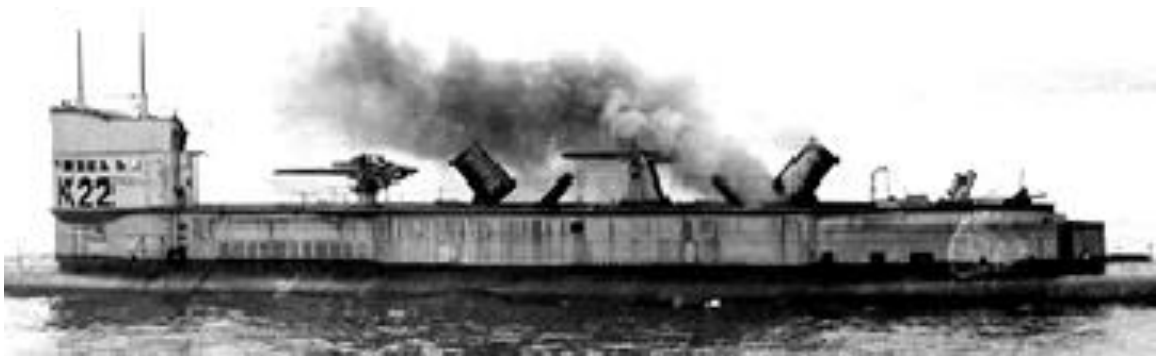
The five-foot tall funnels, located aft of the conning tower, protruded above a substantial superstructure. The funnels were hinged to permit their being tilted downward using geared electric motors and stowed in the superstructure prior to submerging. This evolution resulted in one of the most unusual images of a submarine preparing to dive that has ever been seen.

However, the most distinctive features of the K-class derived directly from their steam power plants. Located aft of the Control Room were the boiler, turbine and motor rooms. Above the boilers were a pair of exhaust trunks and funnels, and four air intakes, which were opened or sealed closed by motor-operated valves before diving. Each of the air intakes was 37 inches in diameter.

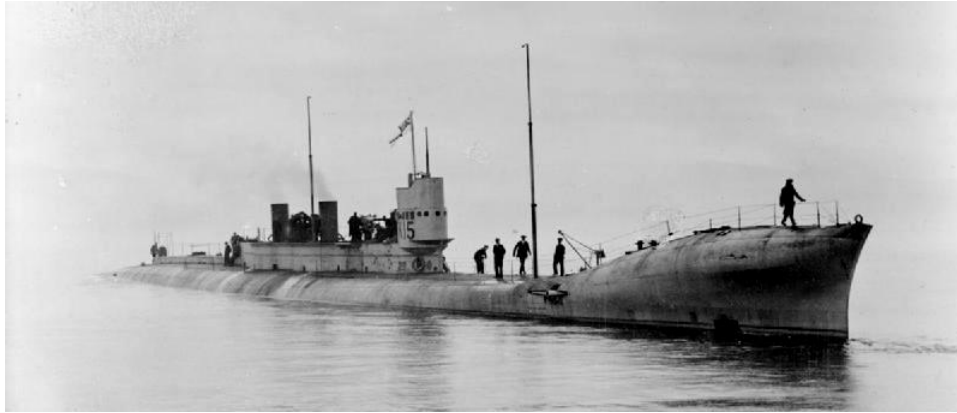
The entire class was later back-fitted with huge bulbous bows, depicted below, which their crew referred to as 'Swan Bows' to counteract this undesirable trait. Nevertheless units of the K-class was still only able to keep up with the British Grand Fleet under the most favorable weather conditions...the likes of which are seldom seen in the North Sea.

The Royal Navy quickly discovered that the K3 exhibited a strong tendency to plow into oncoming seas while running on the surface, forcing her bow underwater. Tons of sea water deposited on the sub's flat foredeck caused the bow to go even deeper and resulting in a sharp decline in speed.

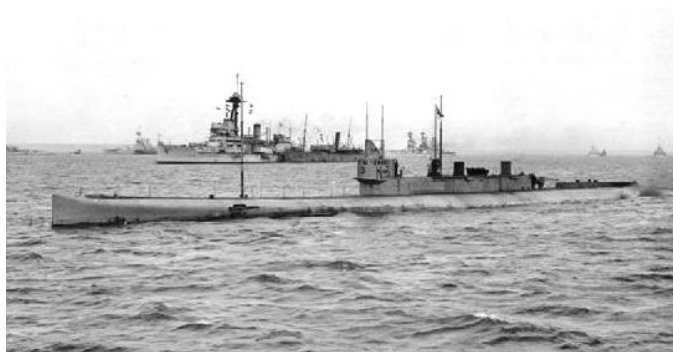
HMS K3 is depicted on the right, passing interned German battleships following the end of World War I. In addition to the previously detailed incident involving K3 and the future king of Great Britain, she was damaged in 1918 when a routine dive resulted in her going too deep and crushing part of her hull.

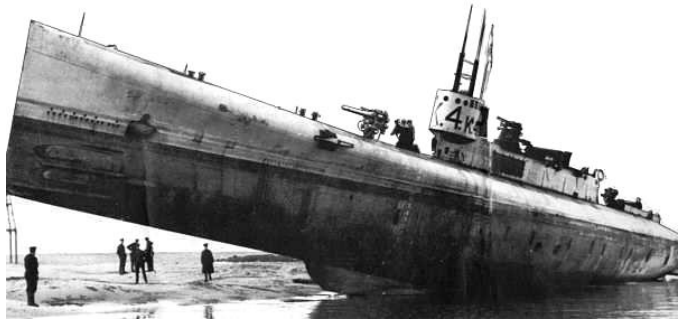
In January of 1917, HMS K4 ran aground at high tide and was stranded...truly high and dry...for days, as shown on the right. Eventually she was refloated, only to first be involved in the aforementioned collision with K1 and then lost with all hands during night time fleet exercises when she was sliced in half by HMS K6.

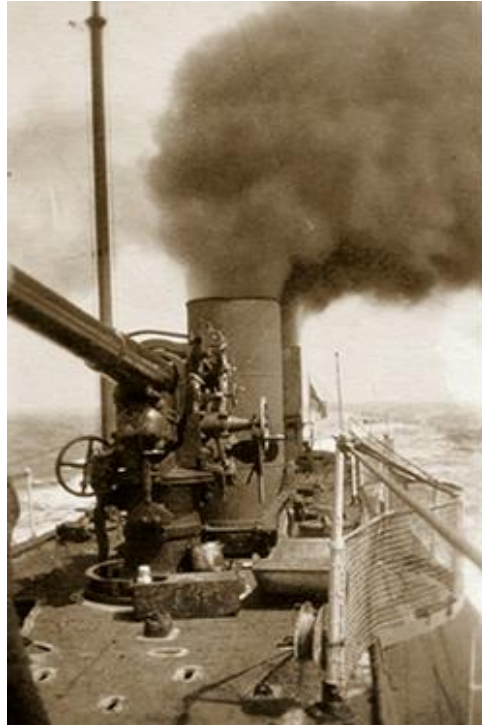
HMS K26, seen on the right, looking aft from her conning tower was the last steam-propelled submarine built anywhere in the world until the nuclear-powered USS NAUTILUS was launched in 1954.
